THERMOMECHANICAL CONTACT PHENOMENA
AND WEAR OF SLIDING COMPONENTS

Final Report

Office of Naval Research

Contract No. N00014-87-K-0125

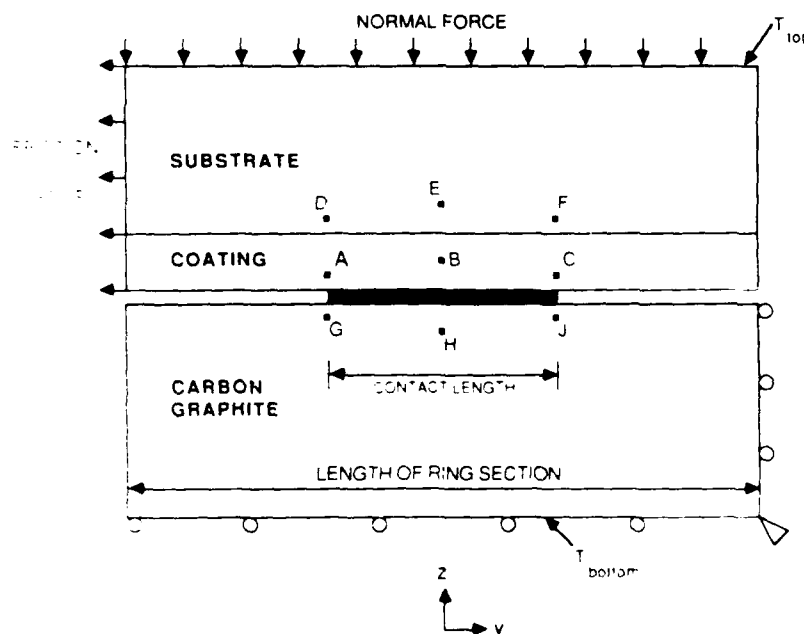
Fig. 1 Schematic diagram of ring section showing boundary conditions for thermal and mechanical analysis and location of nine reference points

radial direction. As heat flowed away from the contact the streamlines would spread, resulting in greater arc lengths and greater effective element thicknesses (and volumes). Thus, elements adjacent to the contact zone would have an effective thickness approximately equal to the radial extent of the contact, while elements further away would be progressively thicker, with the maximum thickness being the ring thickness. This idea is demonstrated in Fig. 3, which shows the lower half of the model of Fig. 1. A similar thickness distribution was used for

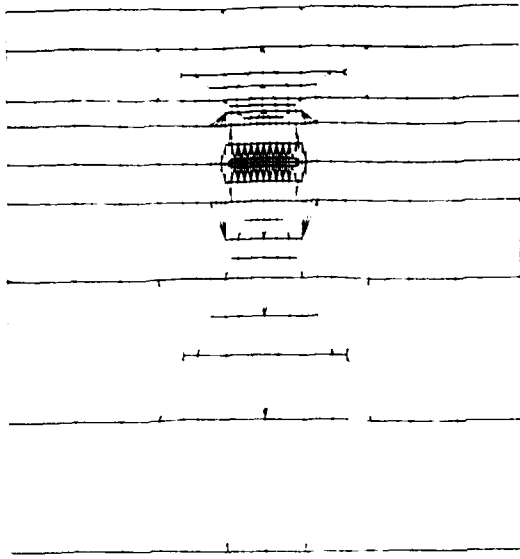
Fig. 2. Central section of mesh generated by AUTOMESH for 1.0 mm long contact patch.

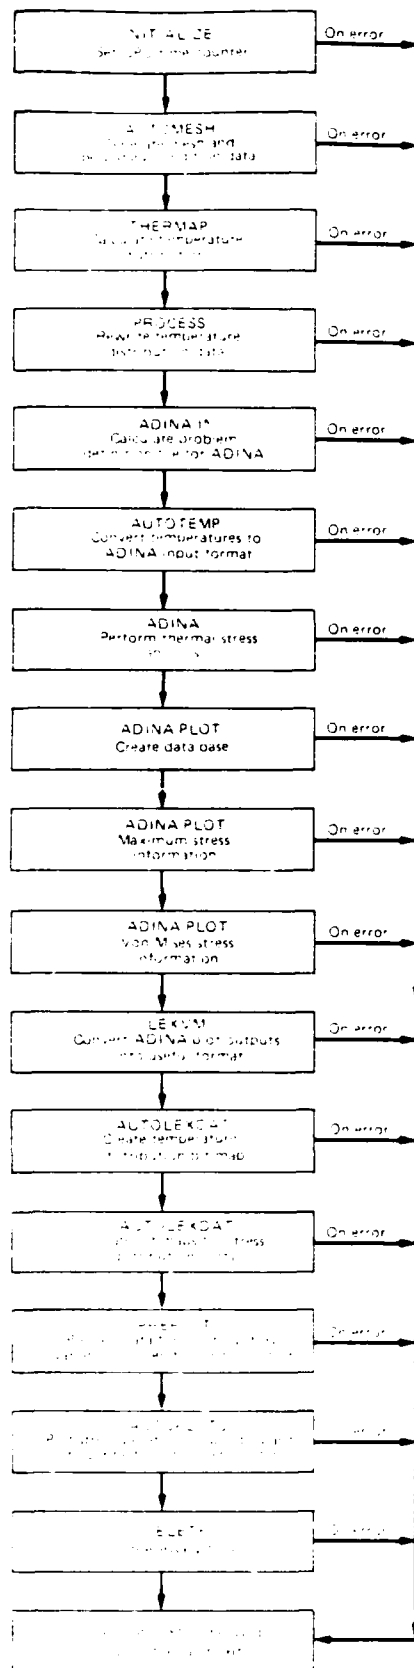
Fig. 4 Flow chart for automated analysis

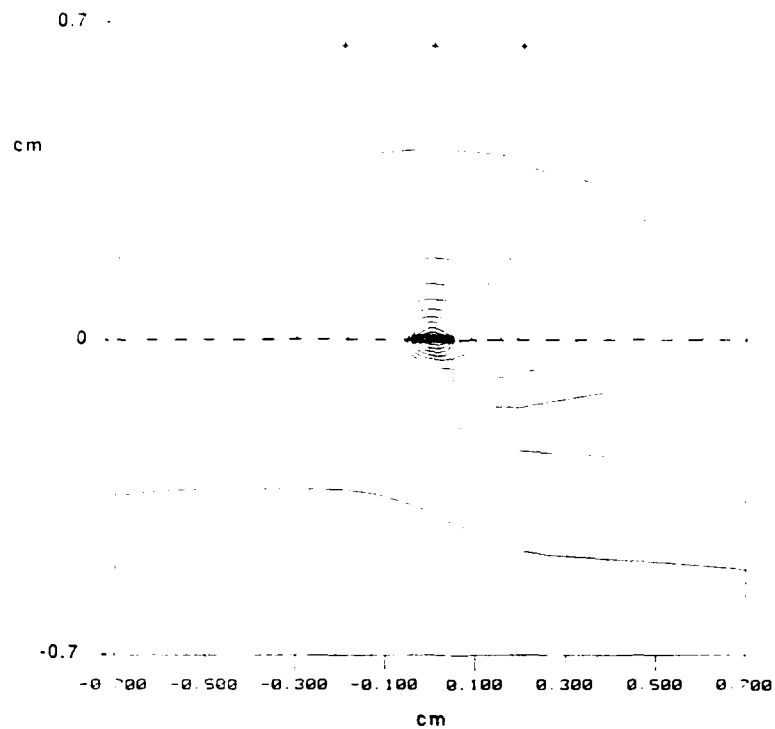
Fig. 5a. Isotherms in ring section for baseline case. Carbon graphite ring is on bottom. Ceramic coating is 0.02 cm thick. Circumferential (ϕ) direction — horizontal in Figure. Axial (z) is vertical.

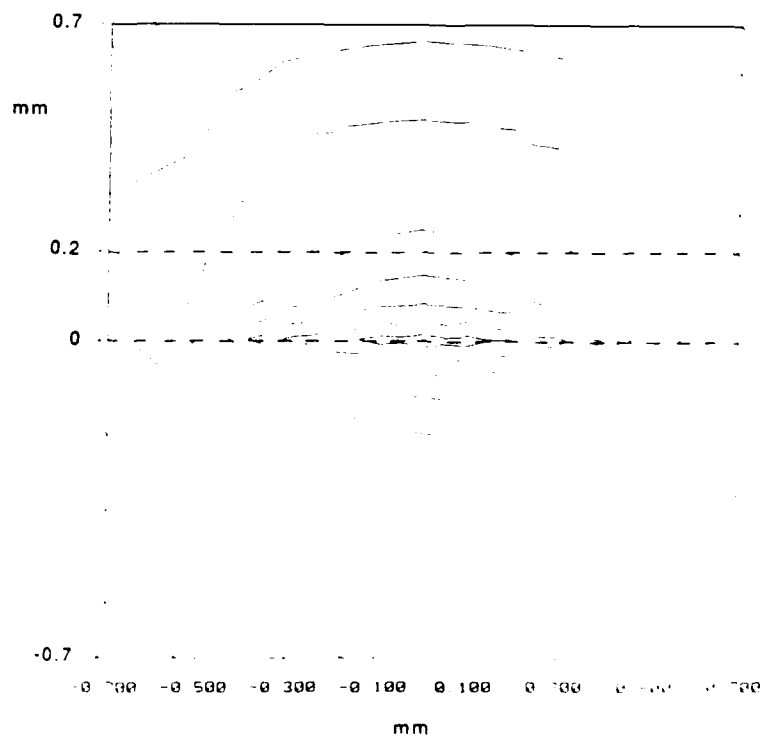
Fig. 5b. Isotherms in contact region of ring section for baseline case. Contact patch extends from $\phi = -0.5$ to $\phi = 0.5$ mm. Ceramic coating is 0.2 mm thick.

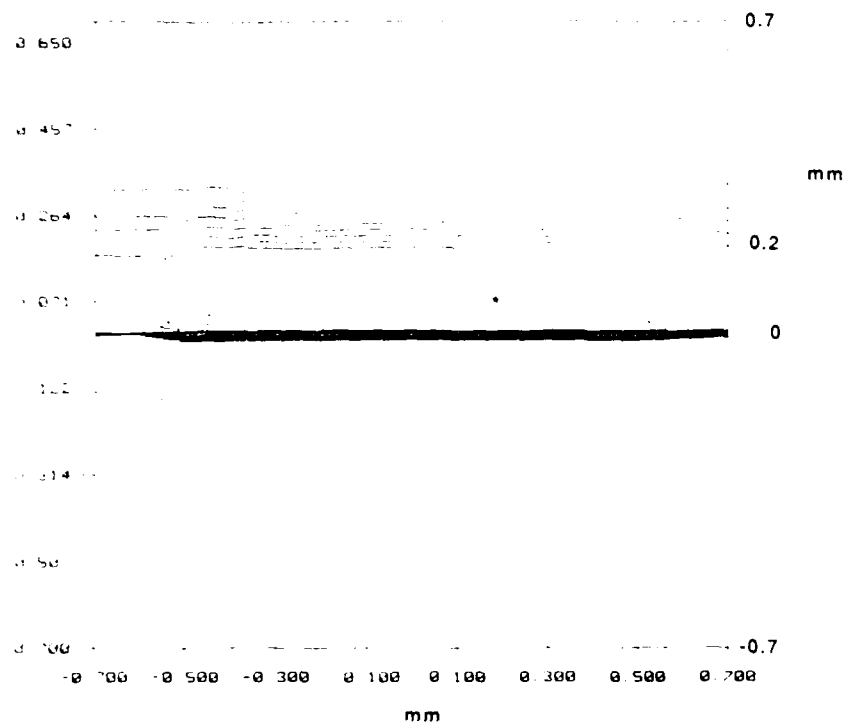
Fig. 6 Lines of constant effective stress (isobars) in contact region of ring section for baseline case. Contact patch extends from $x = -0.5$ to $x = 0.5$ mm. Ceramic coating is 0.2 mm thick.

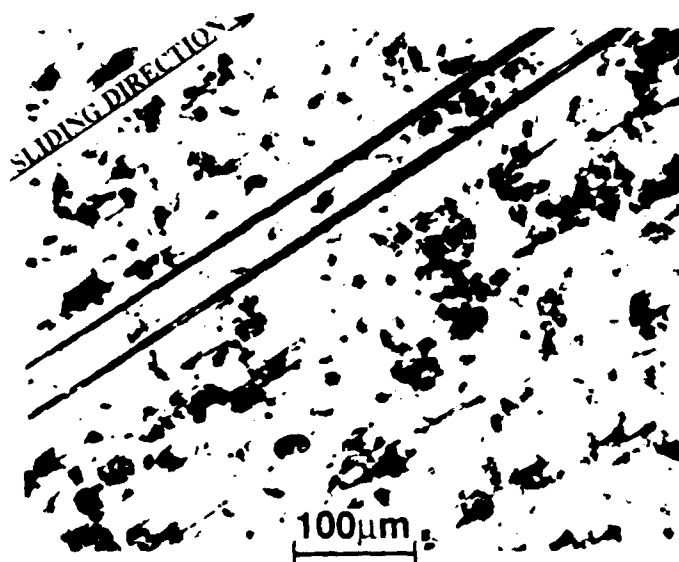
Fig. 1—Optical micrograph of worn SiC surface

Observation of the silicon carbide surfaces after the sliding tests revealed the presence of some thin wear grooves or scratches on the SiC surface. Two examples of such scratches are shown in Fig. 1. Close examination of the scratches showed that each had been caused by a silicon carbide particle which had pulled out and scratched the surface. Carbon wear debris had then collected in the scratches, as can be seen in Fig. 1. Further evidence of the presence of scratches was obtained by characterizing the topography of the SiC surface. Radial surface profiles of the surface before and after a 12 hour test showed the height distributions plotted in Fig. 2. The post-test surface profile was taken across one of the scratches and showed many samples within the valleys. There was generally only a negligible increase in maximum peak-to-valley height, but the roughness average (Ra) increased by 10 percent to 20 percent. The pulled-out SiC particles evidently had remained trapped between the two rings for a period of time and appeared to be responsible for the significant wear of the carbon graphite rings. The surface roughness (Ra) of the carbon rings was found to increase by about 25 percent

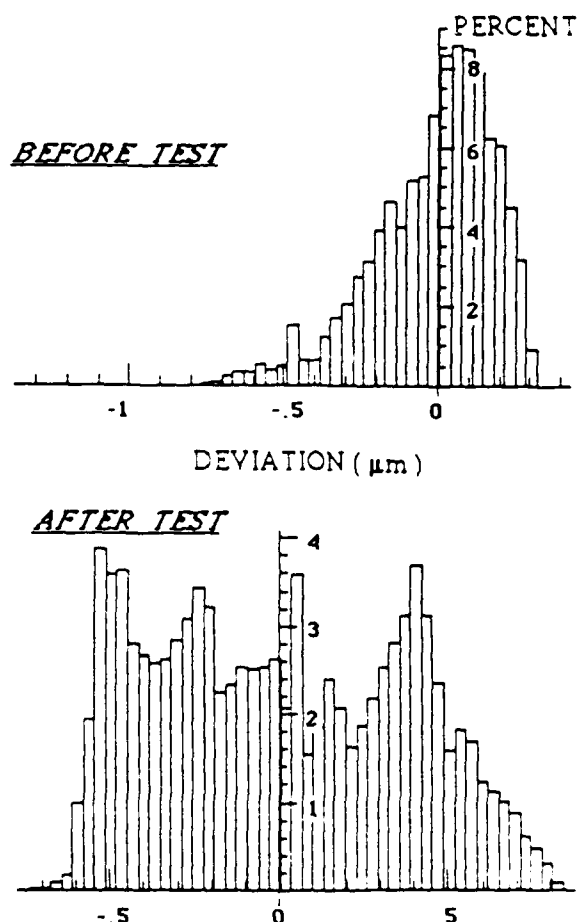
Fig. 2—Distribution of heights (deviation from centerline) for SiC surface before and after sliding test.

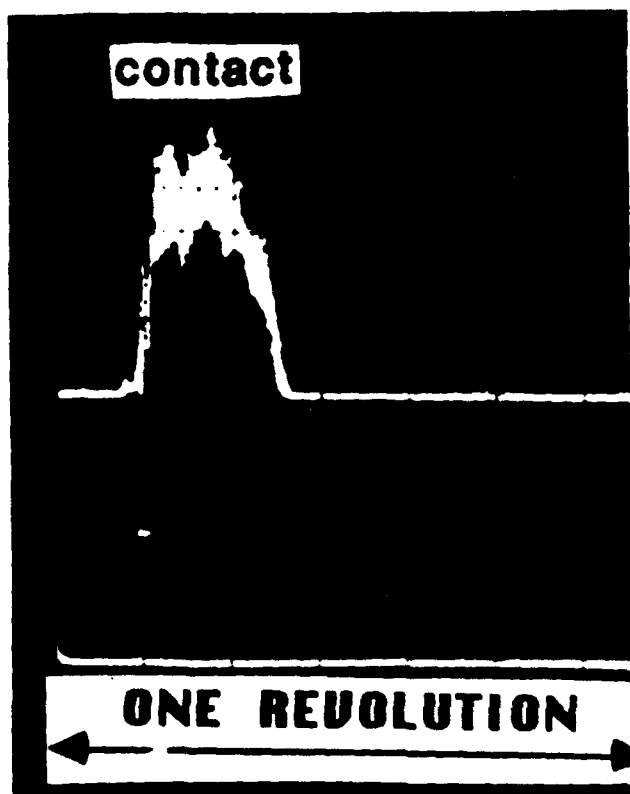
Fig. 3—Typical contact probe output for SiC + TiB₂

where the probe wire was located. A typical contact probe output for a SiC + TiB₂ ring is shown in Fig. 3. It can be seen that many individual asperity contacts were occurring, but the contacts were grouped together within one large patch which covered nearly 30 percent of the ring circumference. The patch location remained approximately fixed relative to the SiC + TiB₂ ring over many revolutions. As the friction burst was about to occur, however, the patch size seemed to grow until it covered nearly 100 percent of the ring circumference. By carefully observing the output from the contact probe, it was determined that the supposed 100 percent contact between SiC + TiB₂ ring and carbon graphite ring was actually large-scale contact between each

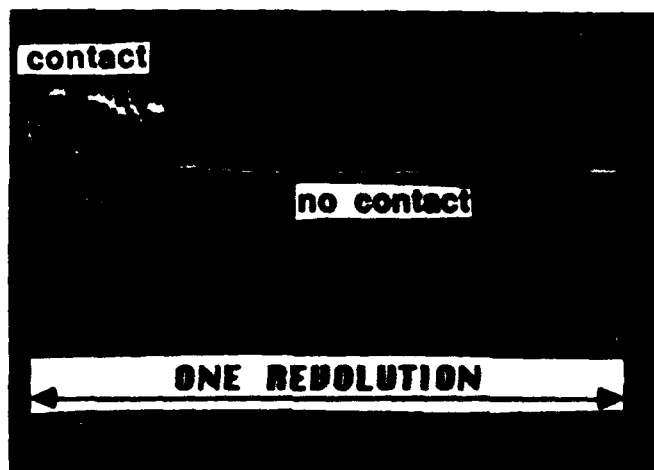
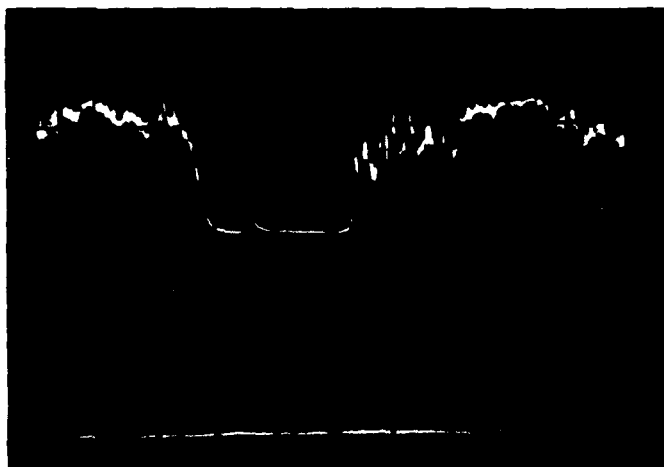
Fig. 5—Contact probe output for WC-coated steel ring sliding against carbon graphite.

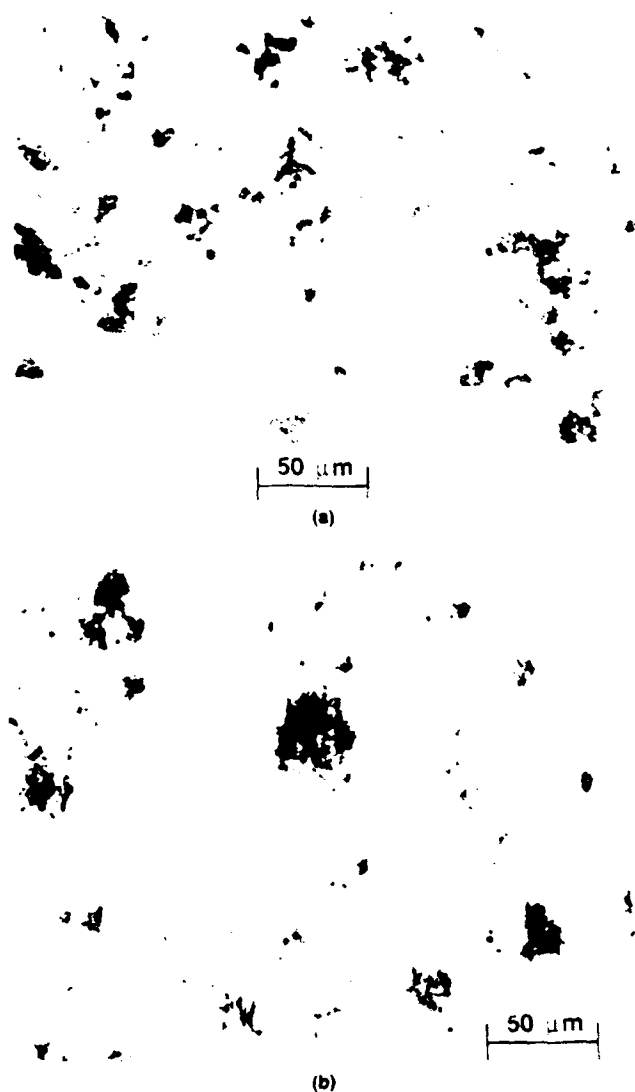
Fig. 6—Optical micrograph of surface of WC coating on steel substrate
(a) Before test
(b) After test

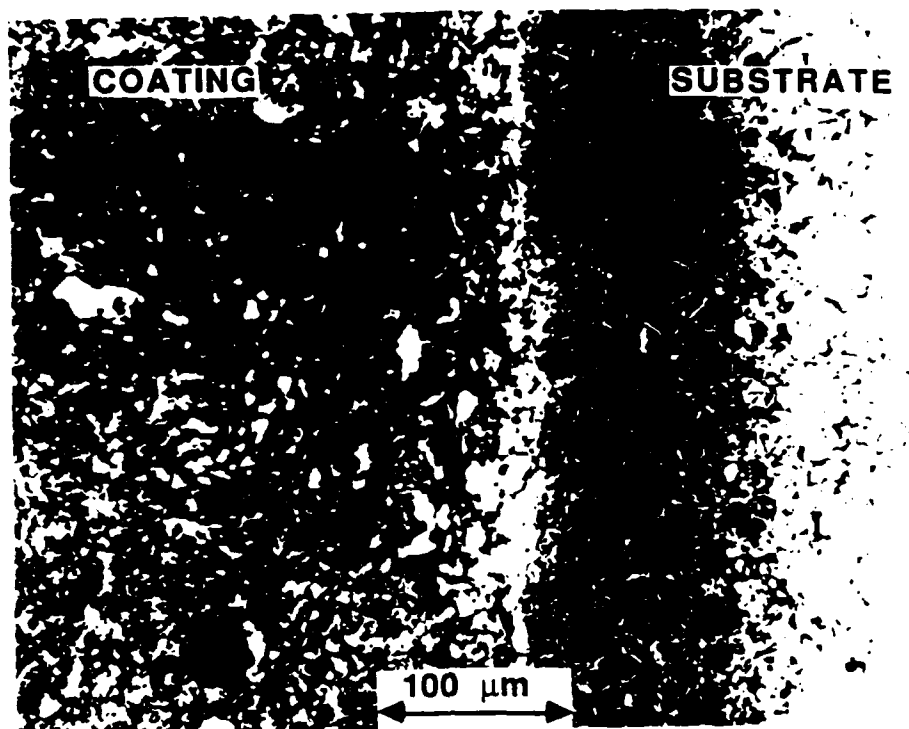
FIGURE 1. Cross-section of plasma-sprayed and heat treated tungsten carbide coating on Inconel 625 substrate.

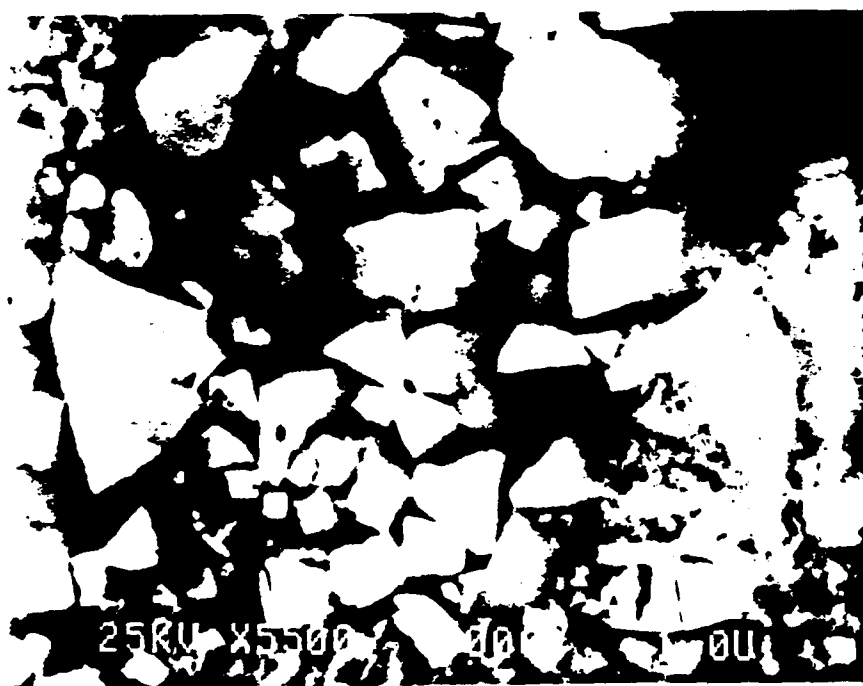
FIGURE 2. Worn surface of tungsten carbide coating surface.

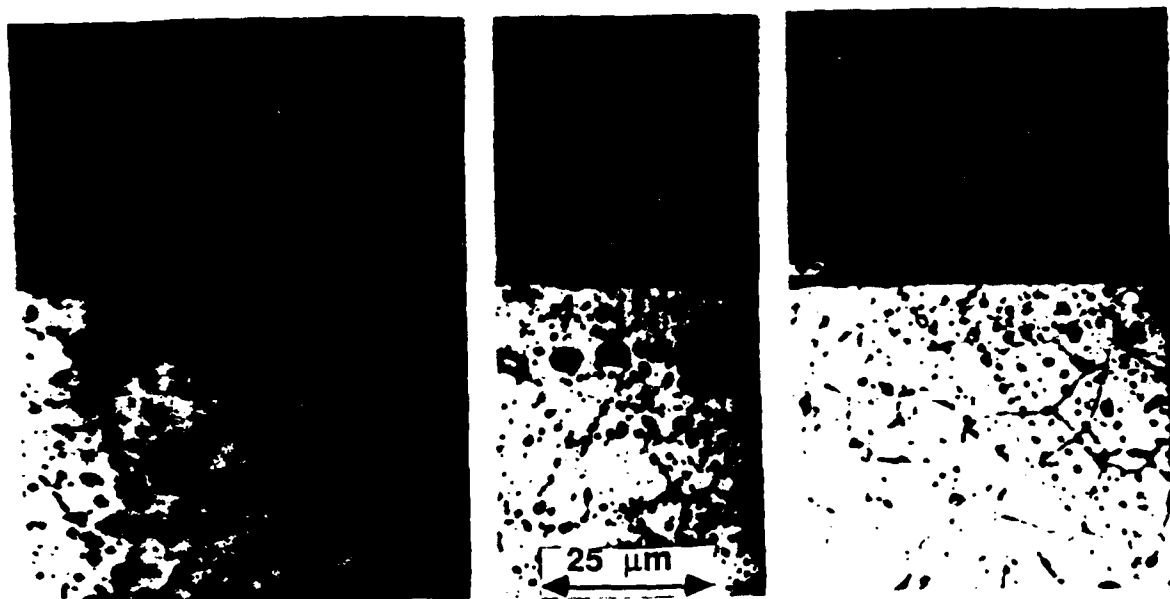
FIGURE 3. Cross-sections of titanium nitride coating outside wear track (left), at edge of wear track (center), and at center of wear track (right).

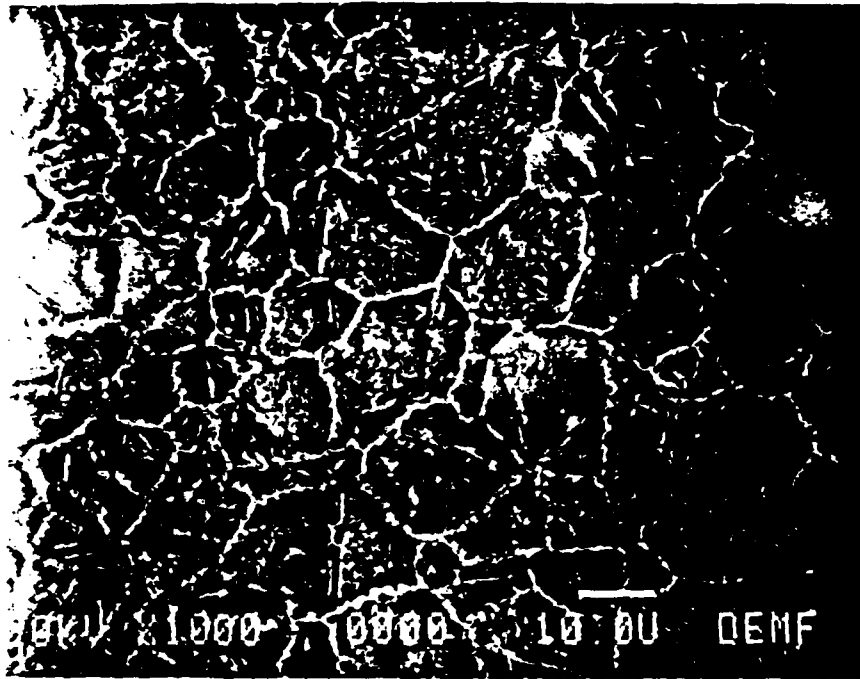
FIGURE 7. Cross-section of tungsten carbide - coated specimen after 30 days in salt water solution. Photograph shows substrate region approximately 300 μm beneath worn surface, with coating interface off photo at left and bulk of substrate at right.

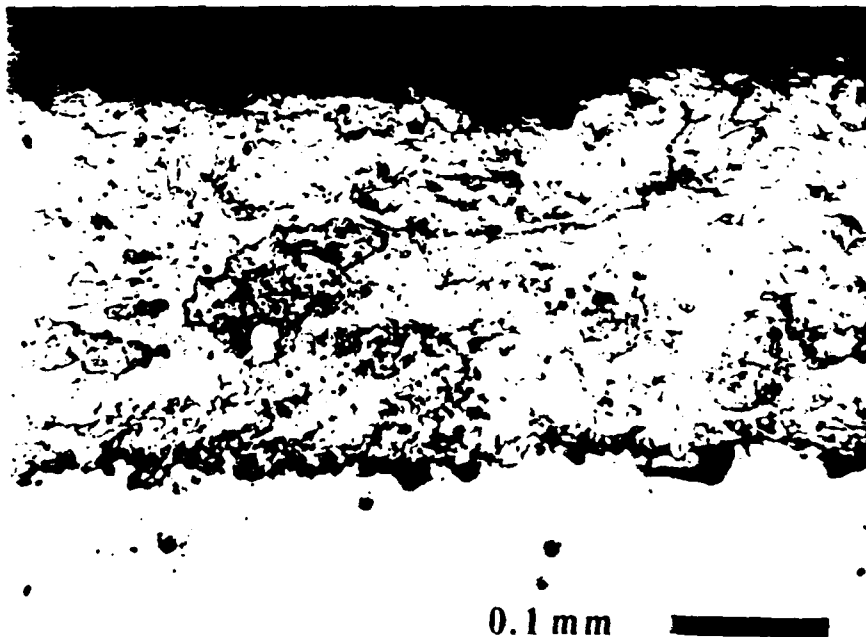
FIGURE 8. Optical micrograph of chromium carbide H coating on Inconel 625 substrate after 60 days in NaCl bath.

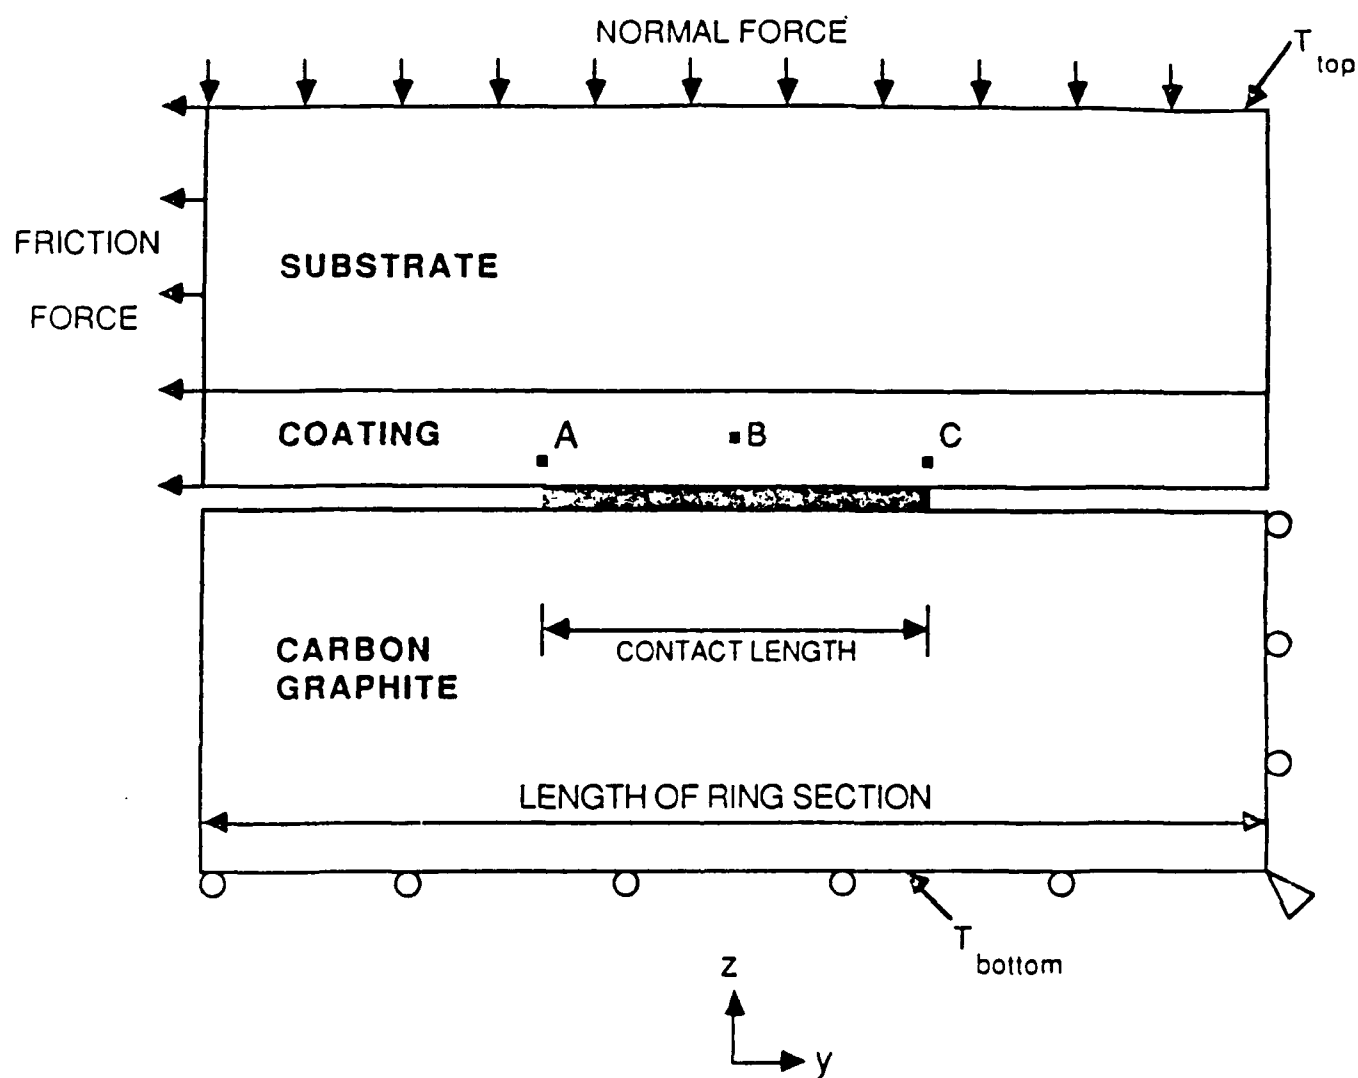
FIGURE 9. Diagram of region modelled in finite element analysis, showing boundary conditions applied.

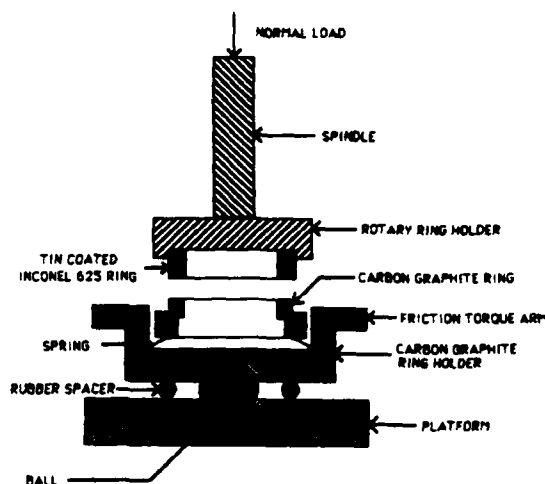
Figure 1 Schematic diagram of wear test apparatus.

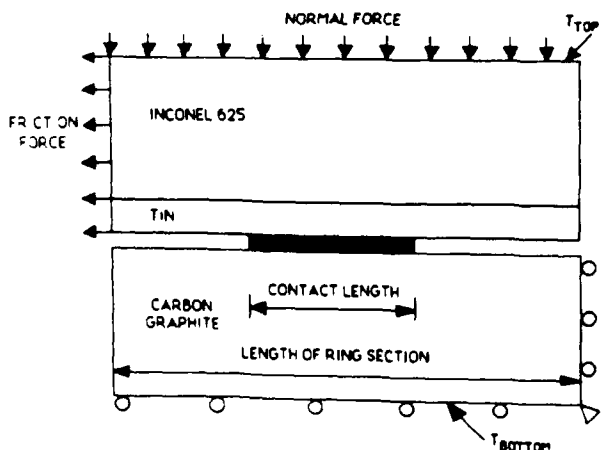
Figure 2 Schematic diagram of ring section for thermal and mechanical analyses.

The boundary conditions for the thermal analysis included setting temperatures on the top and bottom surfaces of the ring section shown in Figure 2. From previous experimental results [1], 150°C and 100°C were assumed to be the temperatures of the non-contacting face of the carbon graphite ring and the TiN-coated Inconel 625 ring respectively.

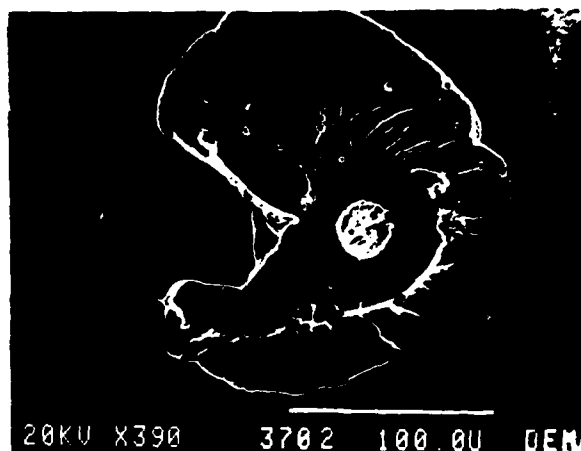
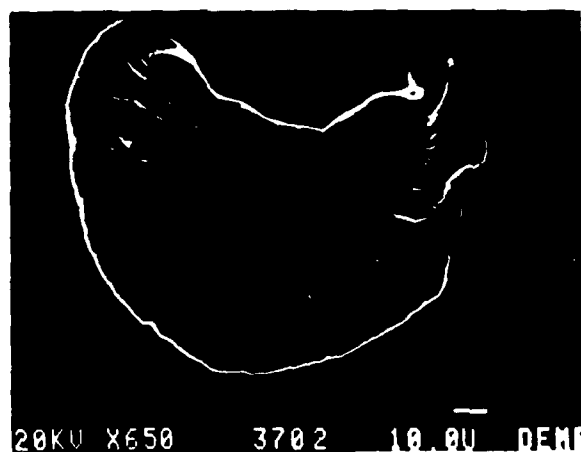
Figure 5 Spalling of TiN coating.

In some cases, if sufficient damage accumulated before the subsurface cracks had propagated parallel to the surface, the cracks could be turned toward the surface by the near-surface tensile stress, and this would result in the spalling of a particle, as in Figure 5.
